# CS900 Antenna Pin Issue

Defect Notice for Bundle Kits Including CM900 Brains

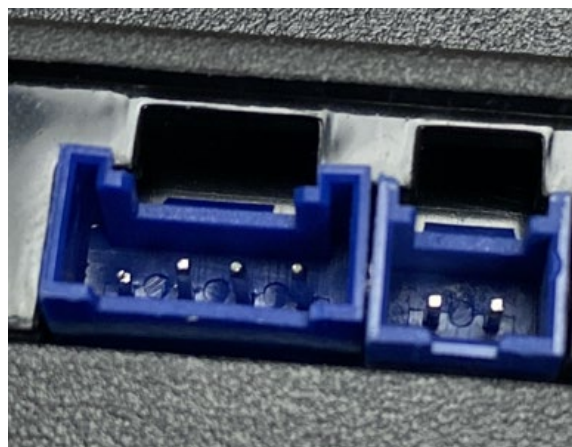
There is an issue with the antenna port on CM900/CM900-AS brains manufactured in August of 2019. This problem will affect RF remote function, programming, and range.

The issue is recognizable to the naked eye. The 4-pin blue antenna port pins will be noticeably misaligned and some connectors are pressed in, resulting in a suboptimal connection with the antenna harness.

Firstech will issue a full warranty advance replacement for units affected by this issue. Please contact your Firstech Sales Representative or Distributor to request advancement replacements of your CM900 and CM900-AS brains. A shipping call tag will also be provided to recall your defective units.

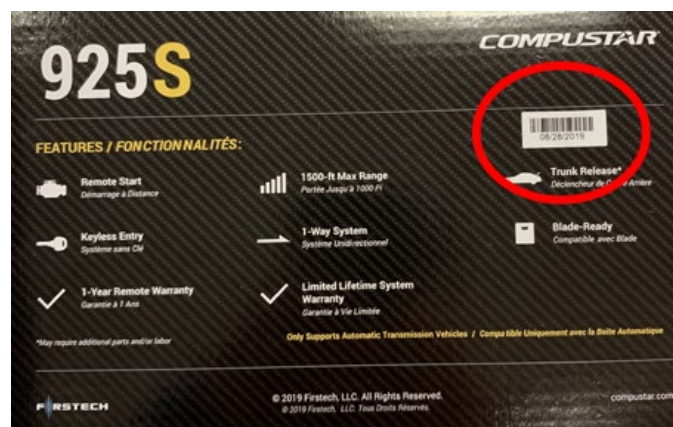
Identify the batch date by inspecting the sticker on the bottom of the kit, next to the features of the kit.
